111-40-10070-2020 TRIBUTARY 2**ADDITION****Water body name:****Survey date:** 10/24/2013**Water body number:****Species & Lifestage:****Watershed:** Mendenhall River-Frontal Gastineau Channel**MTR:** C040S066E **Quad:** Juneau B-2

Table 1.—111-40-10070-2020 tributary 2 survey data.

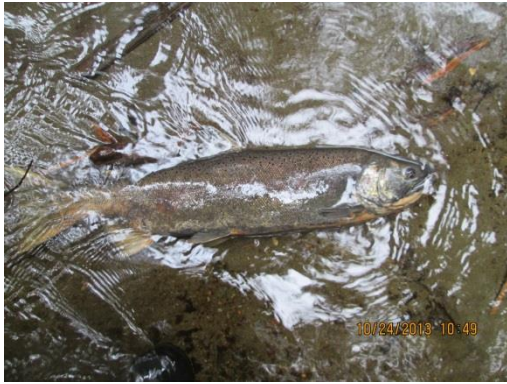
Findings: I surveyed this uncataloged tributary to stream 111-40-10070-2020 using an electrofisher unit and a GPS (Table 1). I captured juvenile coho salmon and Dolly Varden char with electrofisher and visually identified an adult female coho salmon (Figure 1). There was a small cascade that was about 4' that could be a barrier at low flows (Figure 2). I ended the survey due to water level being too low to continue electrofishing.

Figure 1.—Adult female coho salmon.

Recommendations: Add stream to AWC.

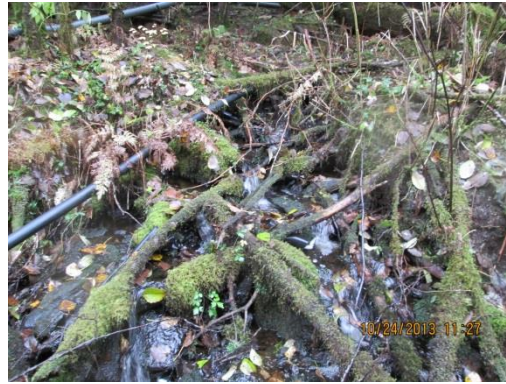
Figure 2.—Possible cascade barrier.
